PolaColor Insight v 5.x SCSI Troubleshooting Guide for SprintScan 45 Ultra, 4000, and 120

Windows XP

This guide is intended to help owners of Polaroid SprintScan scanners solve SCSI communication problems between scanners and computers running the Windows XP operating system.

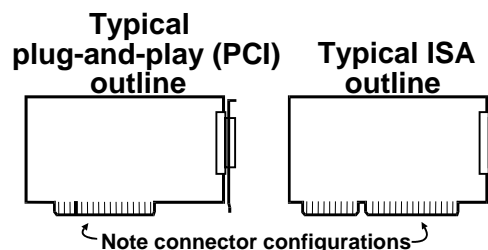
If you do not know your adapter model or if you have a brand or model other than the Adaptec models listed above, you can identify the type by noting the outline of the adapter. The diagram below shows the differences between typical plug-and-play (PCI) adapters and ISA adapters.

If the board outline identifies it as an ISA board, you must replace it with a PCI board.

Adaptec model AVA-1505 and model AVA-1502AE SCSI adapter boards are ISA type and are not compatible with Windows XP. If you have one of these boards, you must replace it with a PCI board.
